Brush Off Your
Troubleshooting skills
And take on a Repair Project!

Repairing the Icom IC-R70 Receiver

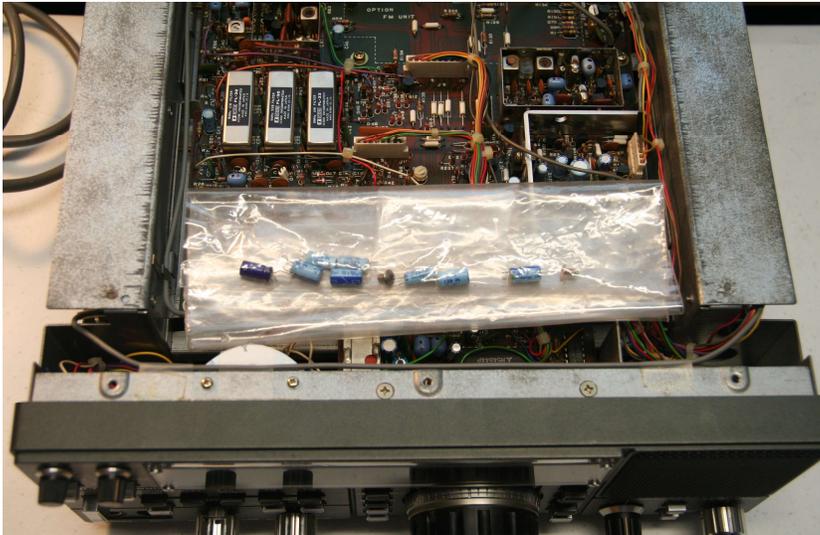
smells or “magic” smoke leaking out! There was audio hiss which varied with the volume control and changed pitch with the tone control (Audio section functioning). Rotation of the RF gain pot muted the receiver and swung the S-Meter to the far right -- all good signs. However, the display only indicated 2 decimal points and none of the front panel buttons activated any features or modes! So it’s time to pop the covers. After removing the top cover I find a small zip lock bag with several electrolytic caps and a few screws. Not exactly what I wanted to find but seems to confirm the info from the original owner.

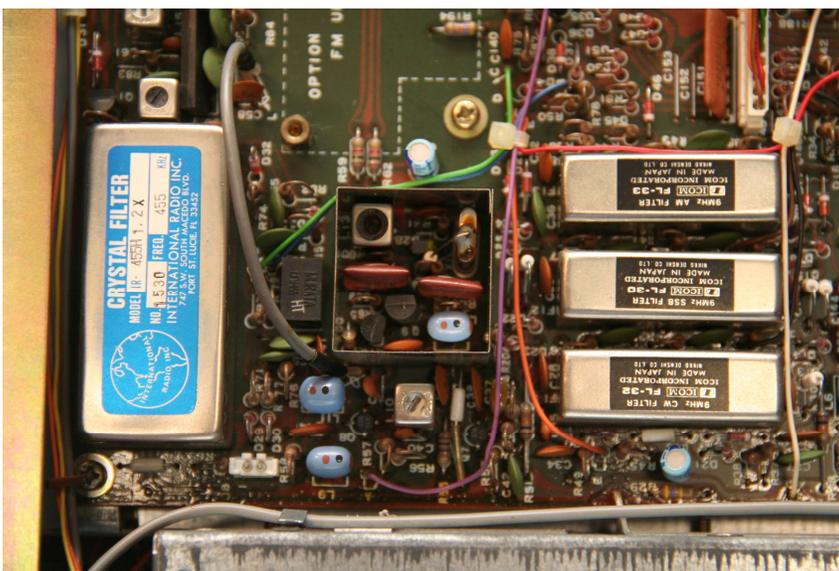
With covers removed, I take a quick look for burnt components, missing parts, disconnected leads, bulging electrolytic capacitors etc. Finding none, I suspect there is a glimmer of hope this Receiver is repairable. I also note this Receiver has an optional InRad SSB XTAL filter in 455 KHz IF section!

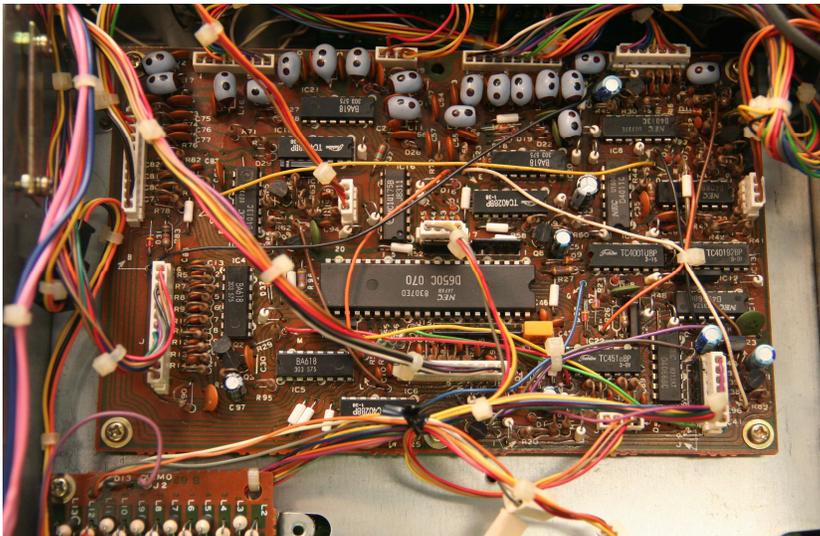
Let's start with some basics. Having already performed a quick visual for obvious issues, the next place I like to look is power supply voltages. Reviewing the schematic I find all main supply voltages are present and reasonably close to spec. Taking a look at the block diagram and thinking about the symptoms, it seems to me there must be a logic board problem. So I next start looking in the vicinity of the main logic chip for presence of VCC, clock signals, I/O activity etc. The main logic chip (a 42 pin DIP) has VCC present and utilizing my scope to probe the appropriate pins, I determine the clock is running. However, probing various I/O lines with my scope indicates no activity. This could signal a quick end to this project if the Custom logic chip is dead and is composed of the dreaded element in the Periodic Chart known as "unobtainium".

Reviewing the circuit diagram for the logic board, I notice several power supply voltages are utilized outside of the basic supply voltages checked earlier. By probing nodes with my DVM, I quickly determine that a 6.2 VDC supply is not present. The problem is traced to a TO-92 pkg. 3 terminal regulator that is defective. I don't have a 6.2 volt version but I do have a 5 volt LM78L05 replacement. I install the LM78L05 after removing the logic board. Power is applied after having reinstalled and reconnected the board. I now have a functional display and the front panel buttons are active! I power down and remove the logic board again and add 2 silicon diode drops in the ground lead of the 5 volt regulator to shift the regulated output slightly north of 6.0 volts. When I power back up, I now have a stable 6.18 VDC supply voltage. (Final repairs include replacing with the proper LM78L62 regulator) The next order of business is to see if I can tune in any signal and begin verification of the various functions of the receiver.

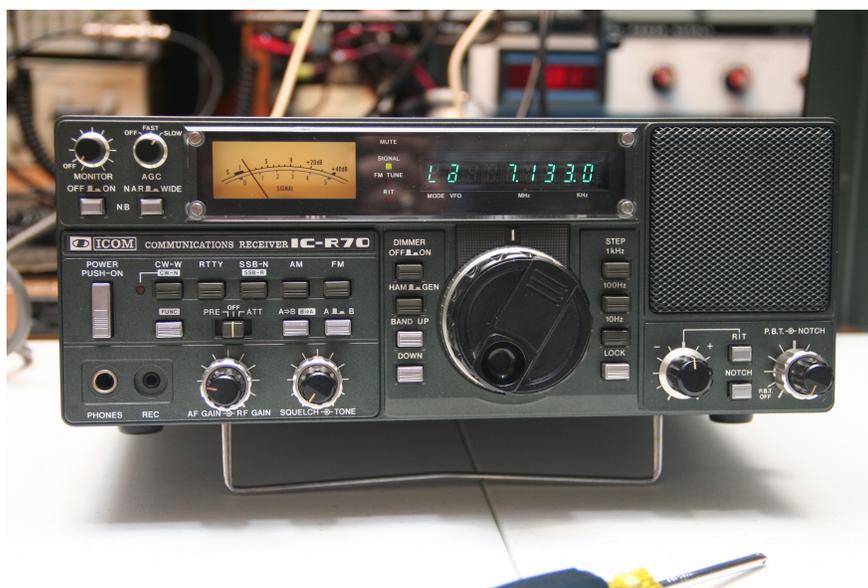
Getting back to the 2nd loop issue, I consult the circuit description section of the SM and after review I am convinced the IC that functions as an oscillator, mixer and amplifier (IC8) is the problem. This is also the chip where I found a short between 2 adjacent pins. I suspect it is now defective as the A/D output from the logic board is providing a stepped DC voltage to the Varactor diode in this circuit when the tuning dial is rotated in the 10 Hz / step mode. Additionally, when the RIT function is selected the Varactor DC voltage swings smoothly positive and negative. Off to the Internet to see how difficult it is going to be to find a TA7310P chip. I find a couple close to me via an auction site and submit a best offer. While I wait for a reply to the offer I decide to do a web search on this chip for a data sheet. The first hit I get on this part is a CB repair site that indicates this chip is used on many CB radios. Hummmmmm, I have a few old Junker CB radios in the shop. I pop the cover on one and low and behold this chip is indeed present. So I heat up the de-soldering station and in about 10 minutes I have this chip removed.

I pull the PLL board back out, remove the can shield cover and solder side shield to expose the chip. The chip is removed; replaced; solder inspected; shield covers soldered back in place and the board reinstalled. This time at power up the received audio now tracks with the VFO in the 10 Hz per step mode! A quick check of the Phase lock voltage in loop 2 shows that it is no longer stuck high. I make the required test equipment connections and adjustments and have it set to specification in short order. A quick check of the various bands and functions indicates we now have a functional receiver again.
