Classic Radio

Reviving the Kenwood TS-530SP Hybrid

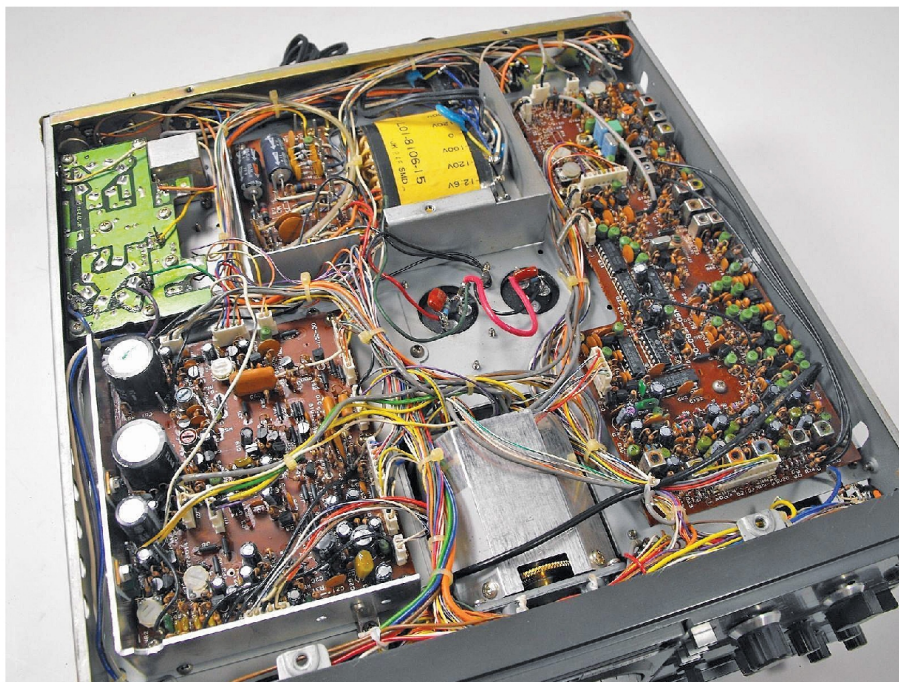
Figure 1 — A look at the inner workings of the TS-530SP.
