Brush Off Your
Troubleshooting skills
And take on a Repair Project!

Repairing the Icom IC-R70 Receiver

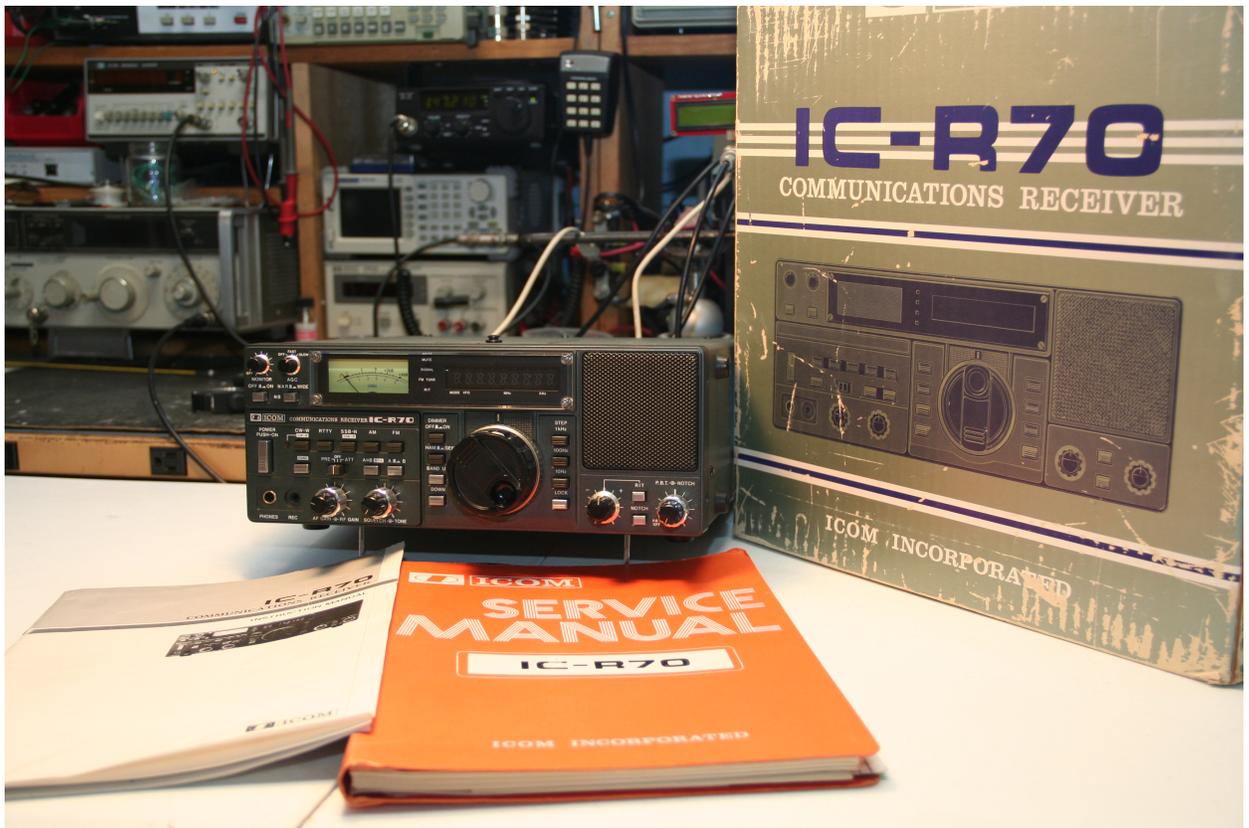
A recent visit to a local “tailgate meet” resulted in my acquiring an Icom IC-R70 Communications Receiver (Circa 1982). The price was right (Free) so I was not going to be surprised if there were some issues. The R70 was in the original box and included the original owner’s manual and the Icom Service Manual (SM) with X-ray circuit board views and a full fold out schematic. The owner indicated he had attempted replacing several capacitors in an effort to restore operation but this did not result in a functional unit.
